CAPITAL PROJECT JUSTIFICATION 2007-2008

TITLE: Unit 2 burner injector / burner replacement

**Intermountain Power Service Corp.
ABT Siemens Warranty Claim**

ABT Siemens Warranty Claim

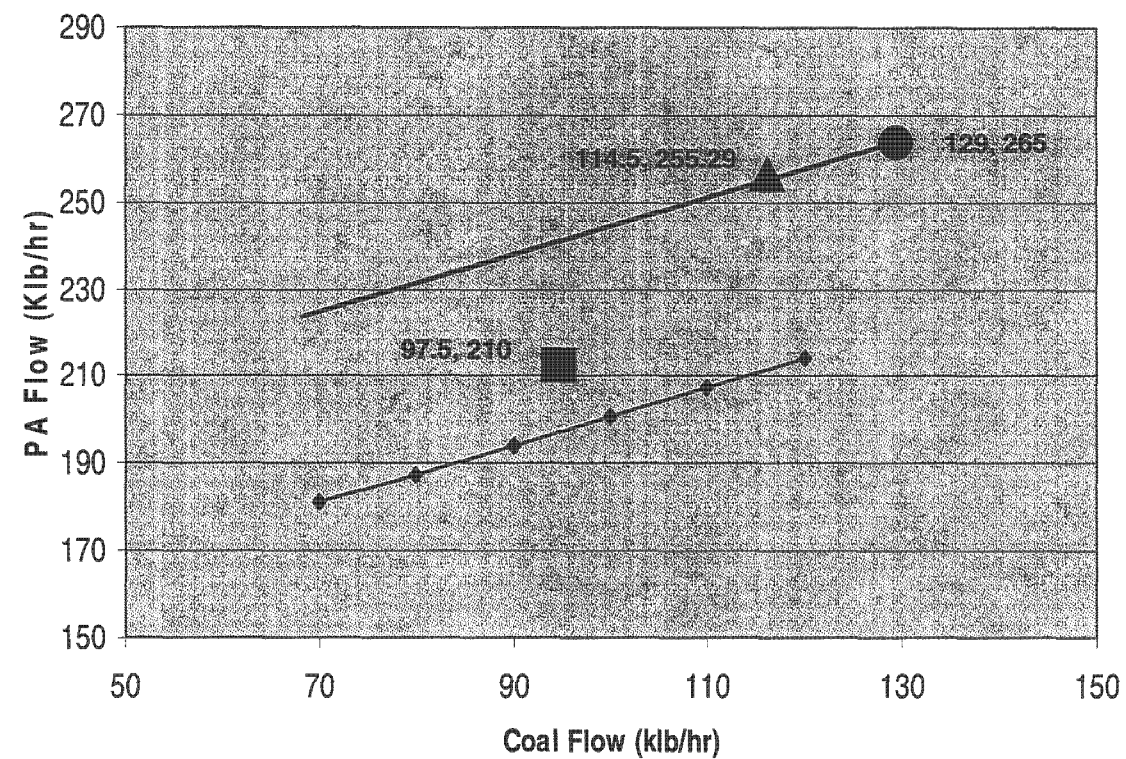
**IPSC - Unit 2
MPS-89 G Mill Curve**

The alloy nozzle tip cracking is the result of erosion of the wall thickness in the nozzle due to higher than original air and coal flow. The thinner wall section weakened the nozzle to the point that the nozzle could not accommodate the stress generated by the differential expansion between the stainless steel nozzle and the carbon steel barrel.

There is material loss at the burner nozzle tip, "X" vane at the coal pipe elbow and the burner barrel are a result of coal and air flows being higher than design plus stratification of the coal particles in the coal pipe entering the 90° elbow.
